DEPARTMENT OF TRANSPORTATION

Quality Assurance and Source Inspection

Contract #: 04-0120F4Cty: SF/ALA Rte: 80 PM: 13.2/13.9File #: 69.28**WELDING INSPECTION REPORT****Resident Engineer:**Pursell, Gary**Address:** 333 Burma Road**City:** Oakland, CA 94607**Report No:** WIR-015919**Date Inspected:** 27-Jul-2010**Project Name:** SAS Superstructure**OSM Arrival Time:** 700**Prime Contractor:** American Bridge/Fluor Enterprises, a JV**OSM Departure Time:** 1900**Contractor:** Zhenhua Port Machinery Company, Ltd (ZPMC), Changxing Island **Location:** Shanghai, China**CWI Name:** Li Yang.**CWI Present:** Yes No**Inspected CWI report:** Yes No N/A**Rod Oven in Use:** Yes No N/A**Electrode to specification:** Yes No N/A**Weld Procedures Followed:** Yes No N/A**Qualified Welders:** Yes No N/A**Verified Joint Fit-up:** Yes No N/A**Approved Drawings:** Yes No N/A**Approved WPS:** Yes No N/A**Delayed / Cancelled:** Yes No N/A**Bridge No:** 34-0006**Component:** OBG components.**Summary of Items Observed:**

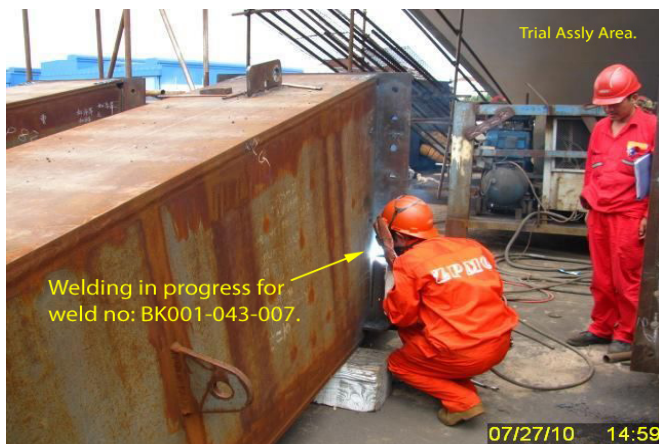
The Flux Cored Arc Welding (FCAW) process on weld joint no: BK001-043-007. The welder was identified as 220066 and was observed welding in the 3G position. ZPMC Quality Control (QC) was identified as Li Yang. The welding variables recorded by QC appeared to comply with WPS: B-T-2233-TC-U4c-F. See attached photo for further details.
